Flood Control Project Maintenance
2008 Structure Summary Report
Overall Unit and Item Ratings

Madera County FCWCA

Structure
Ash And Berenda Slough Control Structures

Flood Control Project Maintenance
Inspection Report - Structure 2008

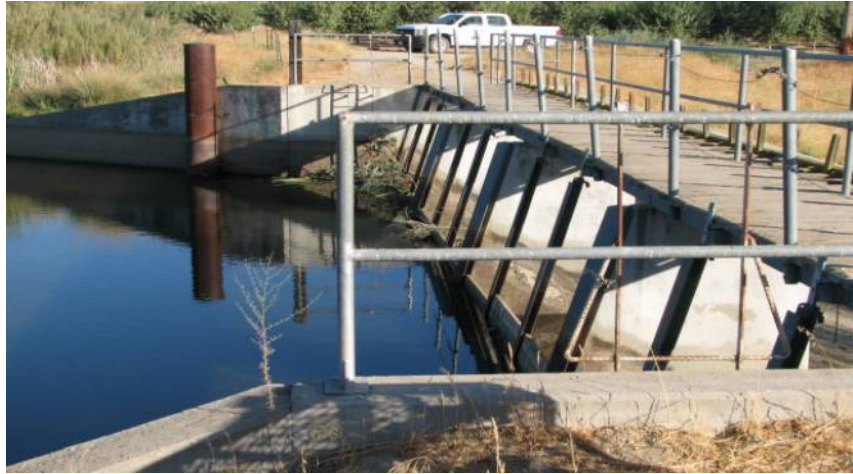
Report Line	3
Location	
Category	Structures & Concrete Lined Channels
Item	Concrete Foundations

The upstream side of the Berenda Structure .

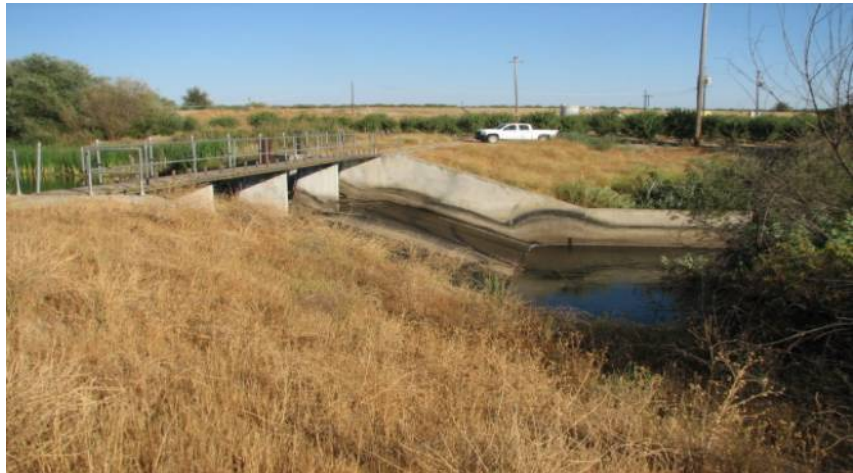
Report Line	3
Location	
Category	Structures & Concrete Lined Channels
Item	Concrete Foundations

The downstream side of the Berenda Structure.

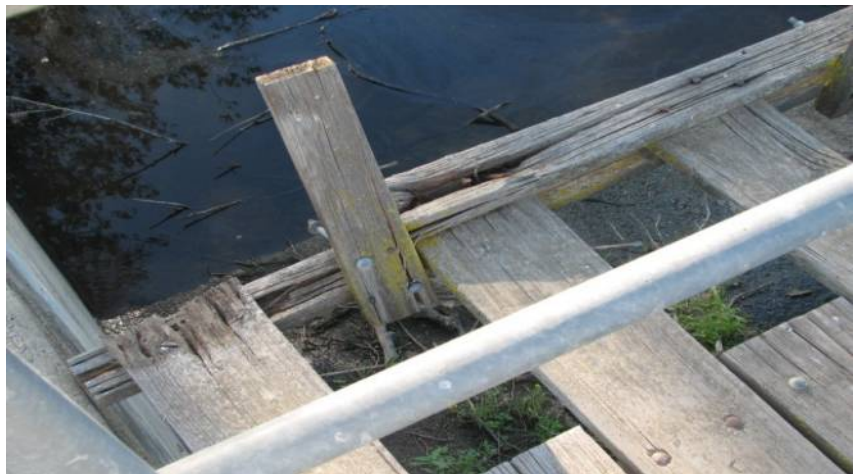
Report Line	3
Location	
Category	Structures & Concrete Lined Channels
Item	Concrete Foundations

photo of damaged boards on the walk way crossing the Ash slough structure located on the left bank side downstream.

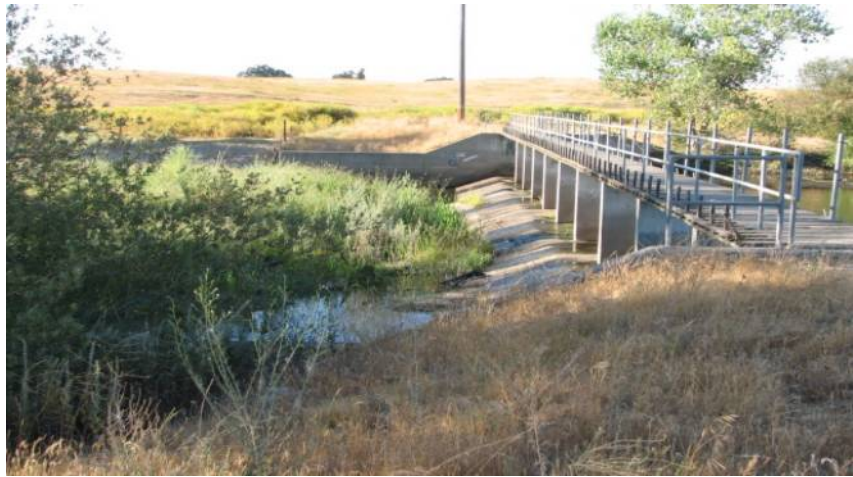
Report Line	5
Location	
Category	Structures & Concrete Lined Channels
Item	Trash Rakes

The downstream side of the Ash Structure. Note the dense vegetation in channel.

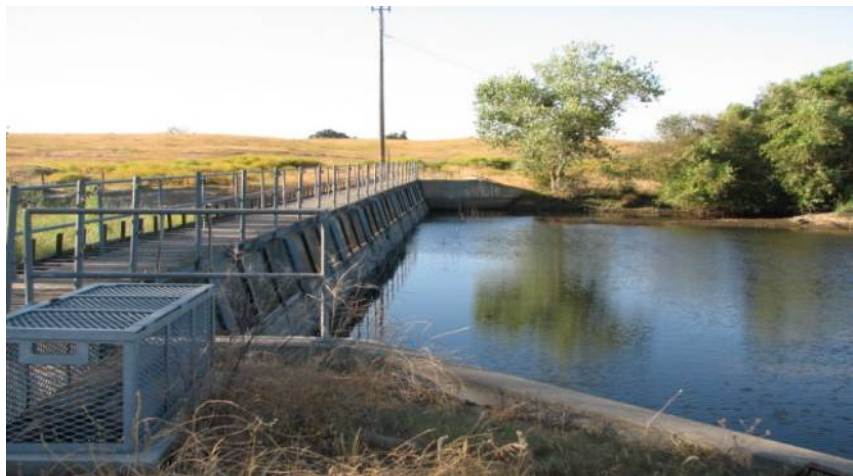
Report Line	5
Location	
Category	Structures & Concrete Lined Channels
Item	Trash Rakes

The upstream side of the Ash structure

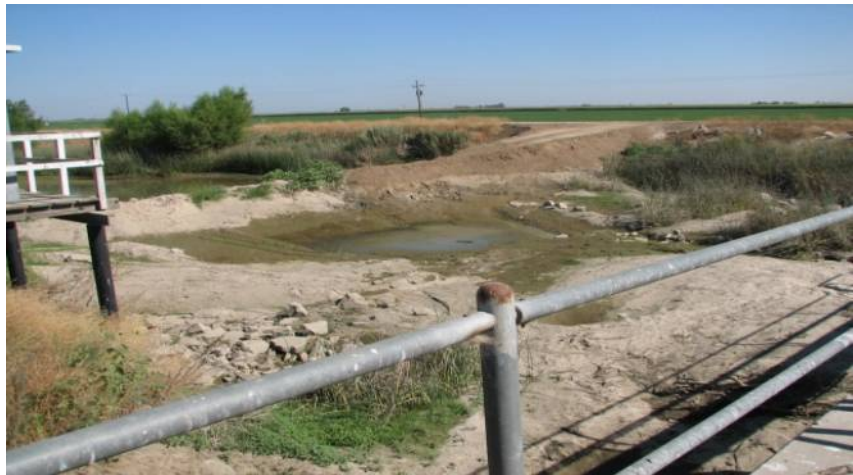
Report Line	1
Location	
Category	Structures & Concrete Lined Channels
Item	Encroachments

Looking south at the unauthorized earthen dam placed across the upstream side of the control structure.

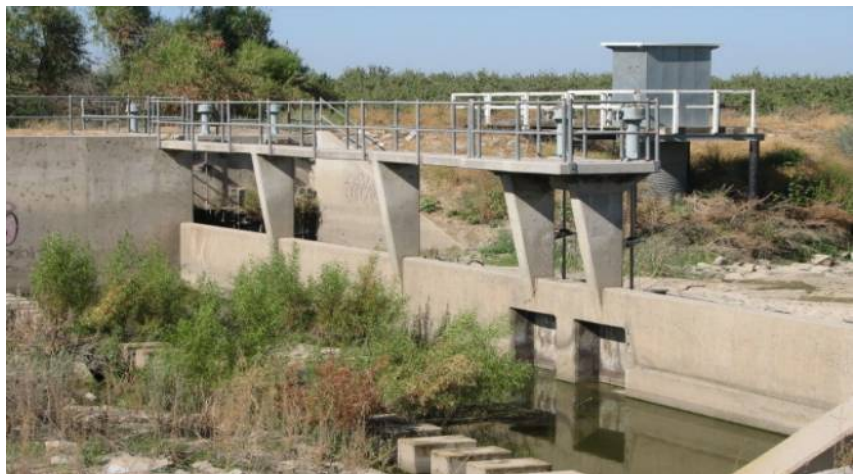
Report Line	2
Location	
Category	Structures & Concrete Lined Channels
Item	Concrete Foundations

View of the velocity dissipaters, stilling basin and wier. This photo shows the wild growth growing in the spilway and downstream of the dissipaters.

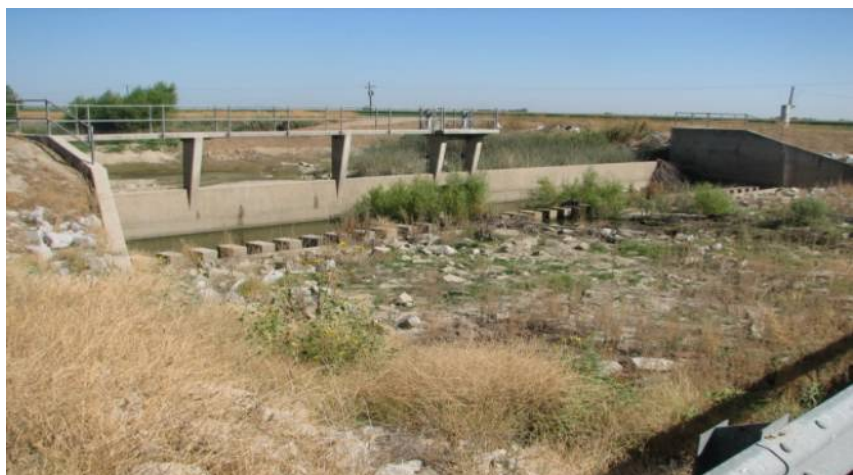
Report Line	2
Location	
Category	Structures & Concrete Lined Channels
Item	Concrete Foundations

Looking south at the diversion weir.
